Three-dimensional Modeling Assists in Investigation of Fires in Oxygen-enriched Environments

After an Expeditionary Deployable Oxygen Concentration System (EDOCS) unit used by the U.S. Air Force experienced an oxygen fire on May 24, 2009, the NASA Johnson Space Center White Sands Test Facility (WSTF) was asked to perform a failure analysis to determine the cause of the fire. The EDOCS unit is a portable oxygen concentration system used to supply concentrated oxygen for medical purposes. The EDOCS module generates oxygen using vacuum swing adsorption technology. The EDOCS-120B concentrator generates 120 liters per minute at 551.6 kPa (80 psi). The oxygen can be delivered directly from the concentrator to the hospital distribution system at 551.6 kPa (80 psi) and/or supplied to the boost compressor. The built-in boost compresses the gas to 15 513.2 kPa (2250 psi) to allow for filling standard medical oxygen cylinders using a cylinder-filling manifold. A vacuum pump is included with the EDOCS to evacuate cylinders prior to filling.

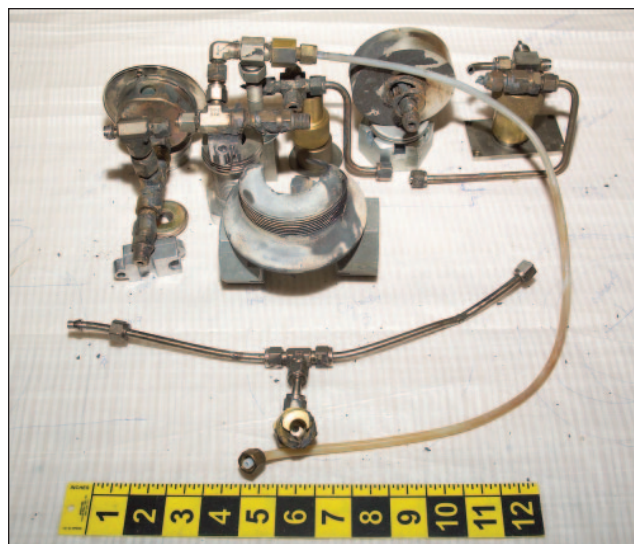
Since the fire incident occurred overseas, only portions of the damaged EDOCS were shipped to WSTF. The WSTF Oxygen Group, using photographs and witness reports as guides, arranged the damaged parts from the system into the original configuration at the time of the fire (figure 1). When reconstructing damaged parts, clues to the cause of a fire are not always obvious, as was the case in the EDOCS failure investigation. After performing a detailed inspection and chemical analysis of the damaged EDOCS parts and evaluating every possible ignition mechanism that could have led to the fire, a model was needed to reconstruct the EDOCS system and compare the damaged system to that of the undamaged, pre-fire system. The fire scenario at this point in the failure investigation was still not clear. While significant damage on the neck of the M-Bottle drew a lot of attention, it lacked some of the characteristic elements for an ignition to occur at that location. Creating computer-aided three-dimensional (3-D) models allowed the WSTF Oxygen Group to compare the two models (pre- and post-fire) to investigate the failure and postulate the most probable ignition and burning scenario (figures 2 and 3). The 3-D models were created from measurements

Fig. 1. Damaged parts in pre-fire arrangement.

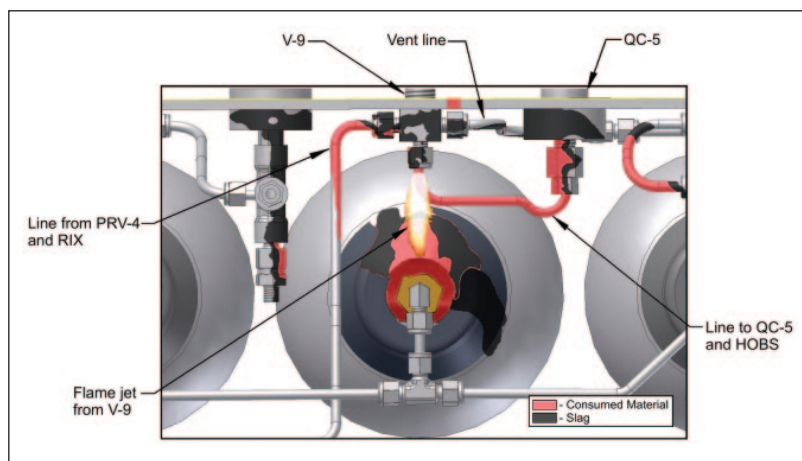
Fig. 2. Flame jet from V-9 impinging on carbon steel M-cylinder u-bolt and cap.

Oxygen rushing from the burned hardline fed the burning stainless steel until the stainless steel failed, causing the release of its contents in a sudden, destructive flame jet that damaged nearby low-pressure or unpressurized components in the oxygen system. A small flame jet from V-9 torched the M-Bottle, which, in turn, caused a lot more damage to the surrounding components.

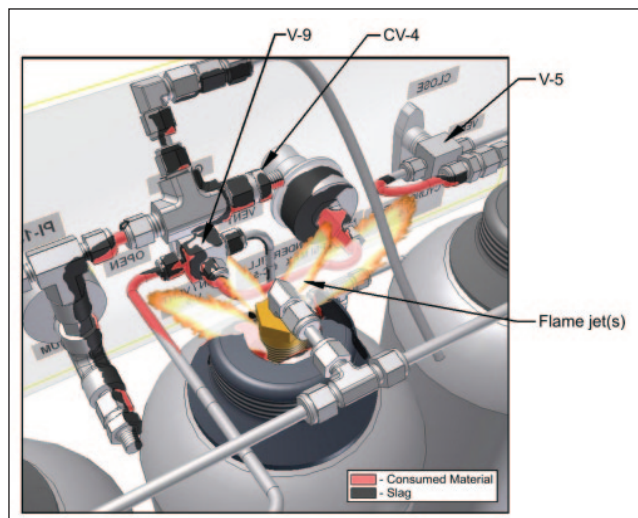
Fig. 3. 3-D illustration used to reconstruct fire scenario.

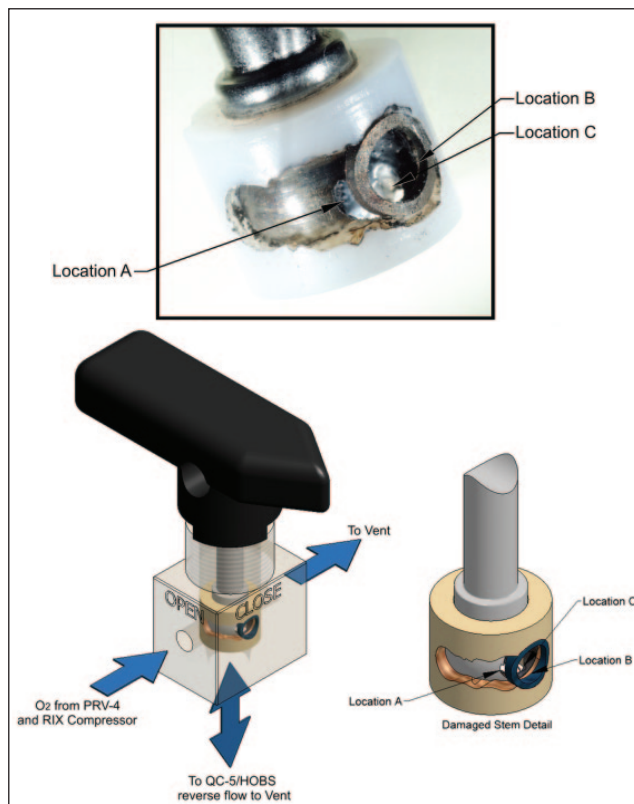
chain. The components that had high pressure in them at the time of the fire included the inlet to V-9, which was pressurized at the inlet to 15 168.5 kPa (2200 psi). The V-9 was inspected visually using a 20 \times power stereo microscope. Damage was observed both internally and externally. Disassembly of the valve revealed extensive internal damage to the valve-stem/capsule-seat assembly. Photographs demonstrated the fire damage, which could then be explained using the 3-D models (figure 4).

The modeling of V-9 told the fire scenario story by showing the flow paths through the damaged component. This V-9 model also led to the discovery that the valve was configured incorrectly, which made it more likely a leak across the seat had occurred and was a contributing factor to this incident.

Through inspection and analysis, the WSTF Oxygen Group determined a “most likely” cause of the EDOCS fire event. The group surmised that a leak of high-pressure, oxygen-enriched gas across the silicone-lubricated, polytetrafluoroethylene-encapsulated seat of V-9 was the initiating cause of the fire that subsequently burned through the downstream 90-deg bend in the 0.64-cm (0.25-in.)-diameter stainless-steel hardline. The group concluded that the fire jet from the burned hardline impinged the carbon steel M-cylinder near its top, igniting the carbon steel.

Fig. 4. Fire damage evidence from photos explained through 3-D models.
